Manhole Inspection Summary

Manhole # S35WW_019MH

Insp Date: **1/8/07 2:03 PM**

Location Address: **3100 CALVERT ST**

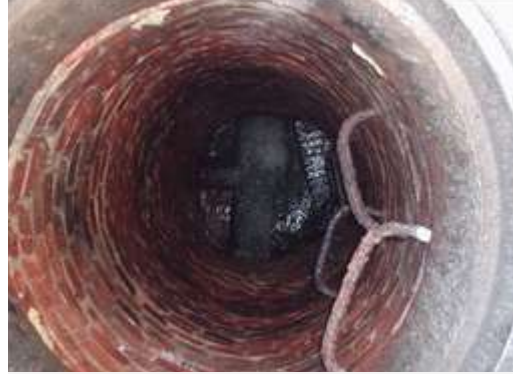
Top View

Condition: ☐ Sound ☐ Cracked ☐ Root Intrusion ☐ Loose Brick ☒ **Deteriorated**

Infiltration: ☐ None ☒ **Joint** ☐ Cracks ☐ Mortar ☐ Roots ☒ **Wall**

☒ **Corroded**

Corroded steps. Adjustment and Barrel infiltration.

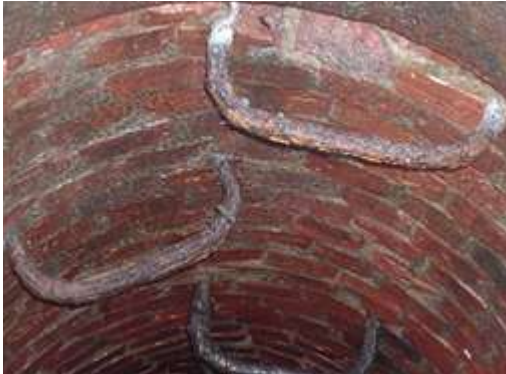
Defect

☒ **Leaks**

Frame leaks. Adjustment deterioration and infiltration.

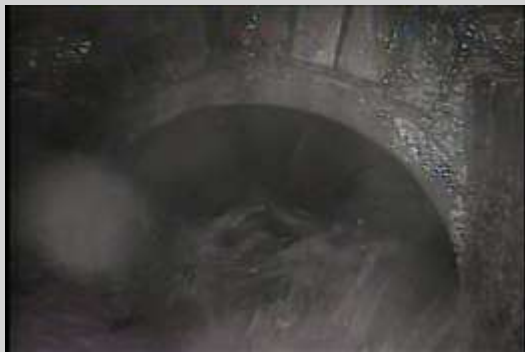
20 in. Circular Gravity Sewer Pipe Out @ 12 O'Clock

Pipe Material: **Clay** ☐ Pipe Lined

Invert Depth: **17.10** (ft.) Flow Characteristics: **Fast**

Infiltration: **None** Pipe Seal Cond: **Unknown**

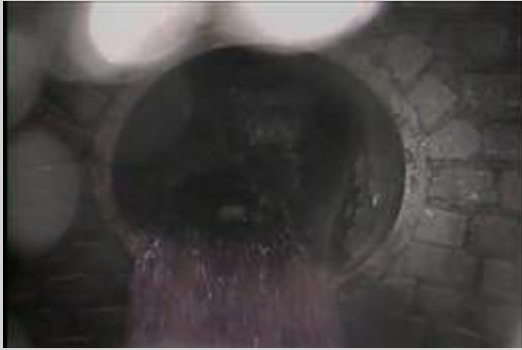
15 in. Circular Gravity Sewer

Pipe In @ 6 O'Clock

Drop: **Outside** Rod and Bar

Drop Condition: **Clogged**

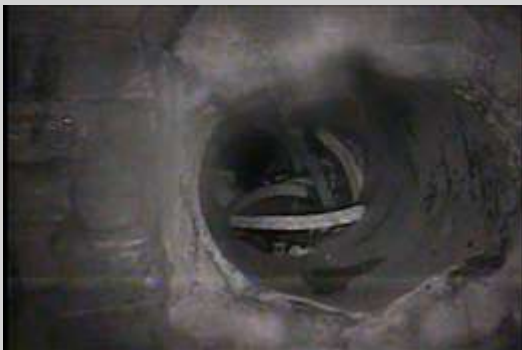
10 in. Circular Gravity Sewer

Pipe In @ 9 O'Clock

Pipe Material: **Clay** ☐ Pipe Lined

Invert Depth: **6.81** (ft.) Flow Characteristics: **Slow**
